Średniowieczne fortyfikacje (X–XIV w.)

Medieval Fortifications (10th–14th c.)

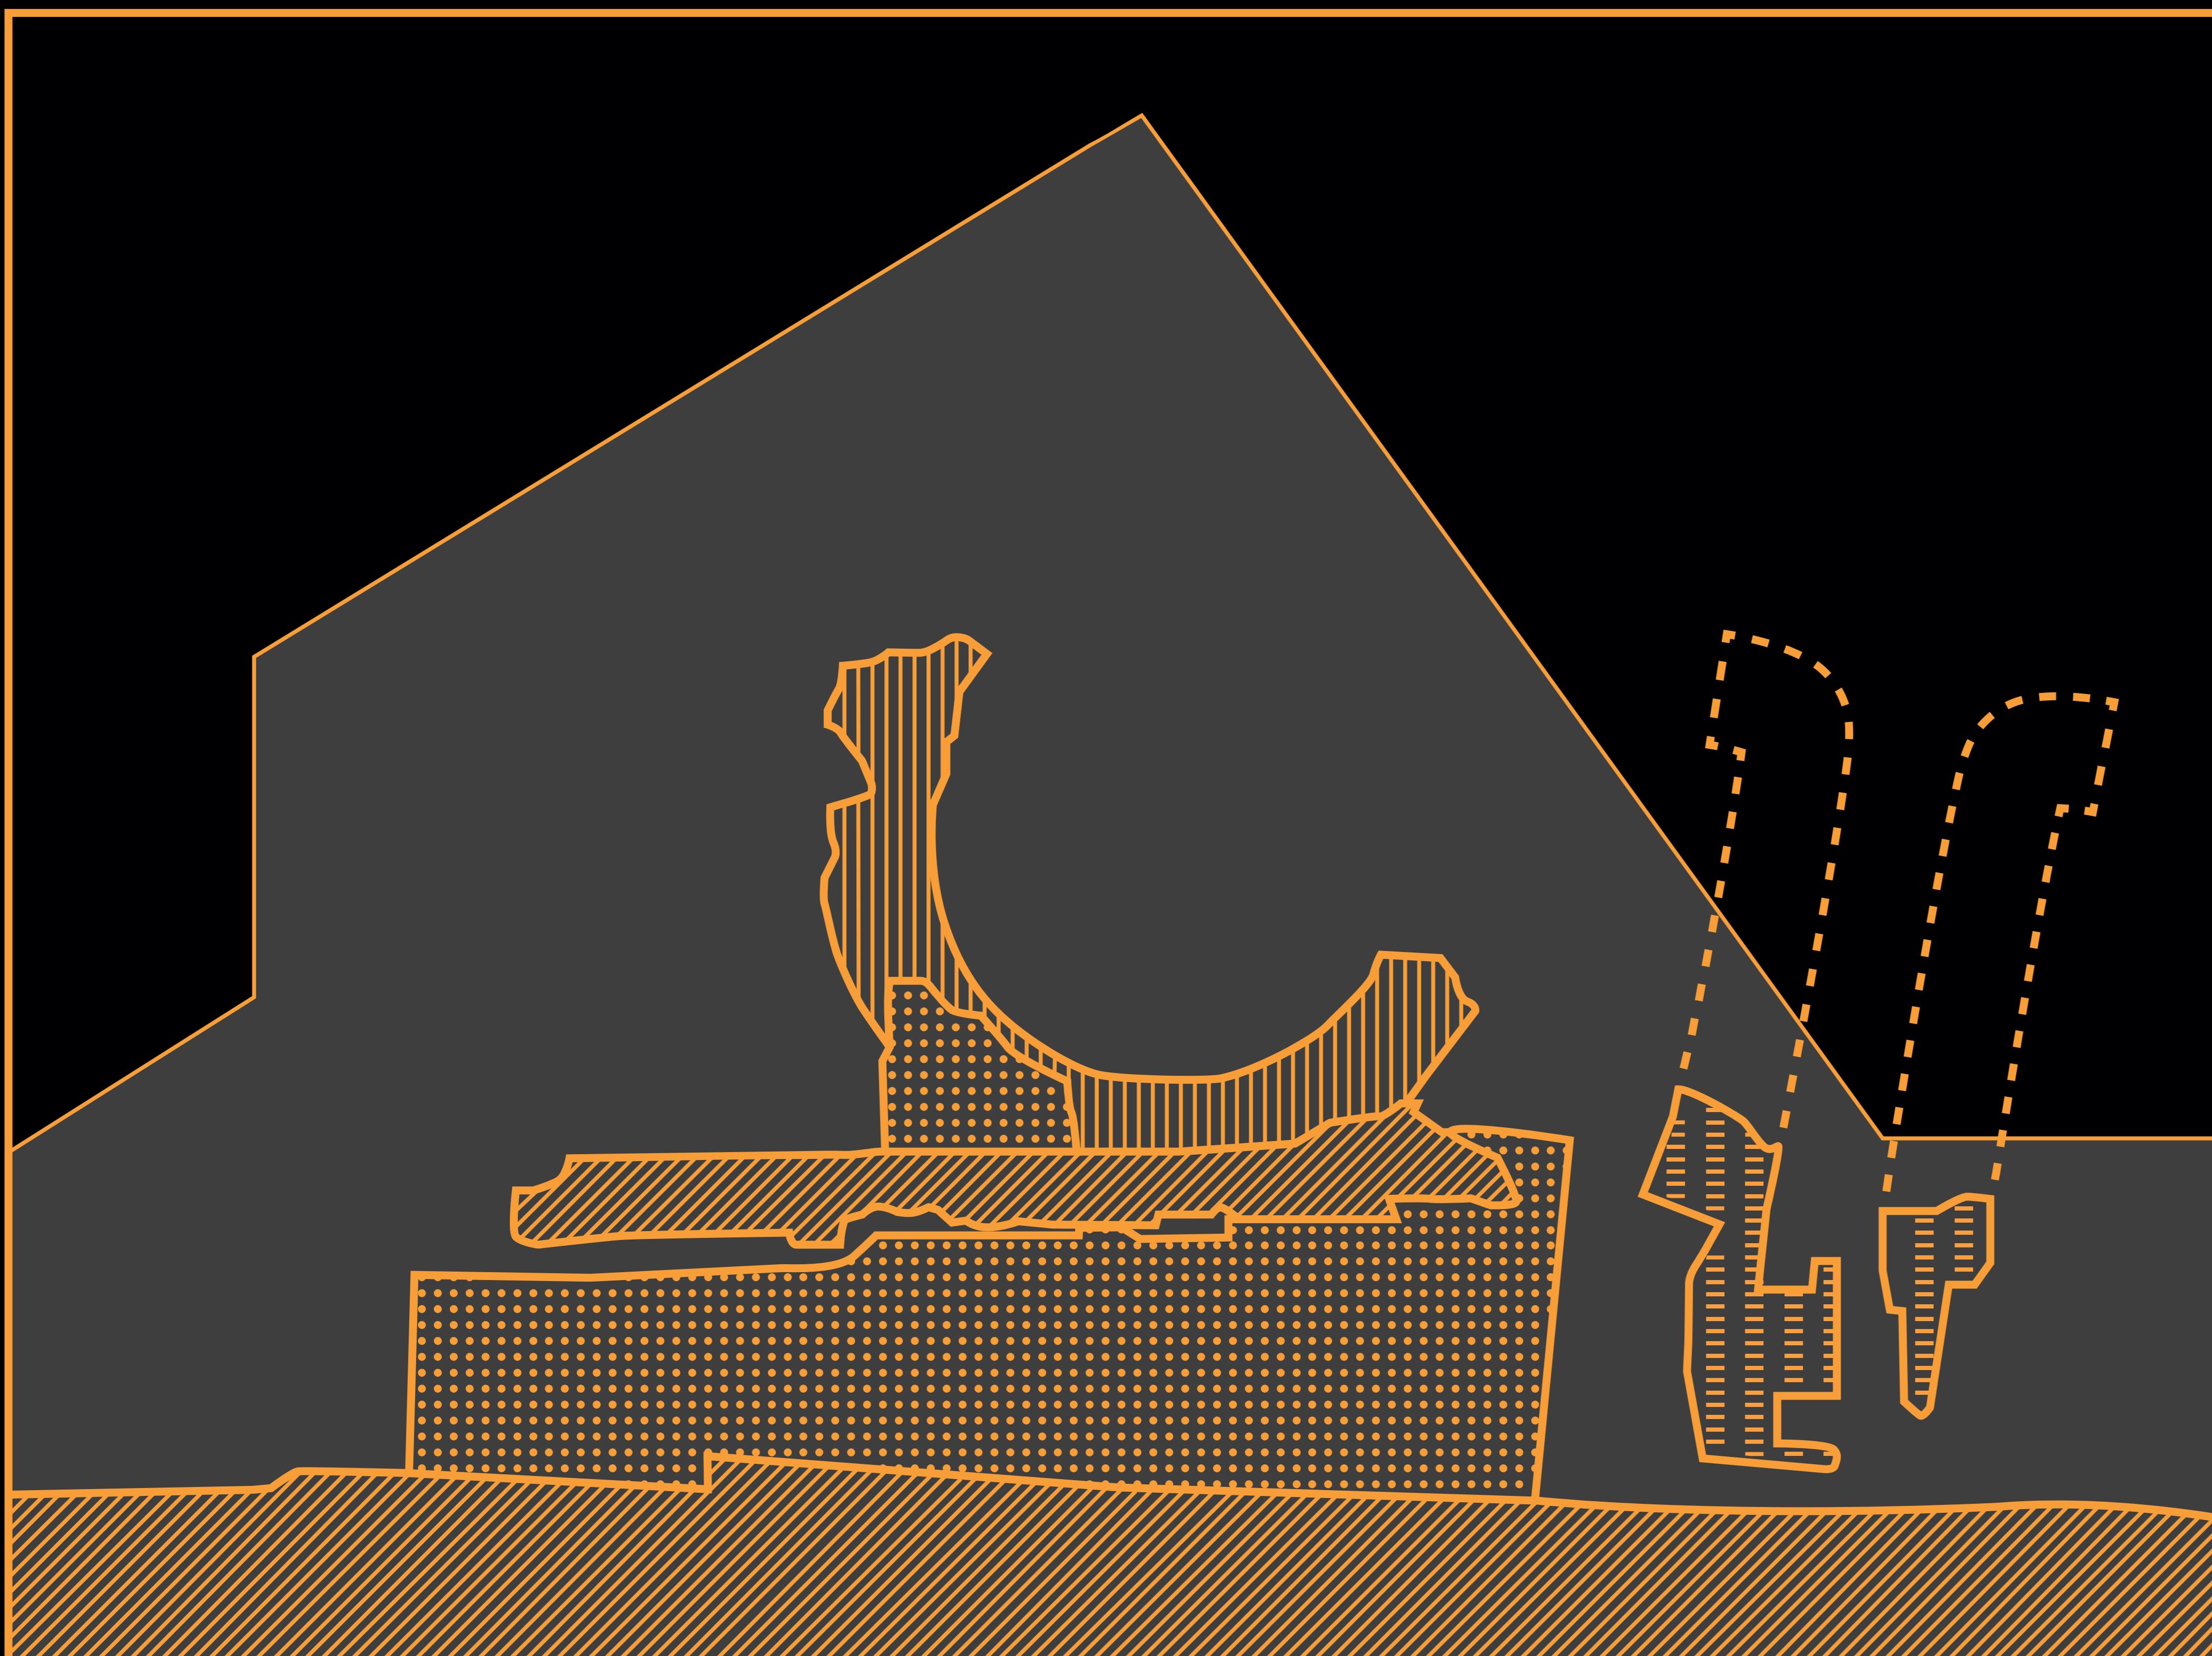
Relikty płytkowego muru (X/XI w.)

Zachowane relikty są interpretowane jako pozostałości po murowanej bramie prowadzącej do przeprawy na prawy brzeg Wisły. Brama składała się z długiej szyi, z której zachowały się wewnętrzne, wschodnie zakończenia, oraz niewielkiej, wewnętrznej wieży bramnej.

Relikty muru z wapiennej kostki (XI/XII w.)

Półkolisty mur, zachowany w części naziemnej do wysokości 1 m, jest uważany obecnie za pozostałość romańskiej wieży obronnej.

Relikty średniowiecznego wału obronnego (XIII w.)

Zachowane elementy konstrukcji ziemnego wału średniowiecznego to prawdopodobnie ława fundamentowa wraz ze śladami wewnętrznej, drewnianej konstrukcji. Było to potężne umocnienie, odpowiadające skalą wcześniejszemu.

Kamienny mur obronny (XIV w.)

Pierwsza murowana fortyfikacja wzgórza została wzniesiona przy użyciu różnej wielkości kamieni wapiennych, uzupełnianych fragmentami cegieł, które były wiązane zaprawą wapieno-piaskową.

Relics of a Slab Stone Wall (10th/11th c.)

The preserved relics have been interpreted as the remnants of a masonry gate, which opened onto a ford across the Vistula River to its right bank. The gate comprises a long passage of which the inner eastern ends have survived, and a small inner gate tower.

Relics of a Wall Built of Limestone blocks (11th/12th c.)

The semicircular wall, whose above-ground section is preserved to a height of 1 meter, is now believed to be the remains of a Romanesque defensive tower.

Relics of Ramparts from the Middle Ages (13th c.)

The preserved elements of an earthen rampart structure of the medieval period are probably a stone foundation with traces of an internal timber structure. It was a massive fortification, corresponding in scale to the earlier one.

Stone Defensive Wall (14th c.)

The first masonry fortification of Wawel Hill was raised using pieces of limestone of various sizes supplemented with brick fragments that were bonded with lime-sand mortar.
