## Zewnętrzne mury kleszczowe

## Outer Tenaille Fortifications

### Zewnętrzne mury kleszczowe (XVIII/XIX w.)

### Outer Tenaille Fortifications (18th/19th c.)

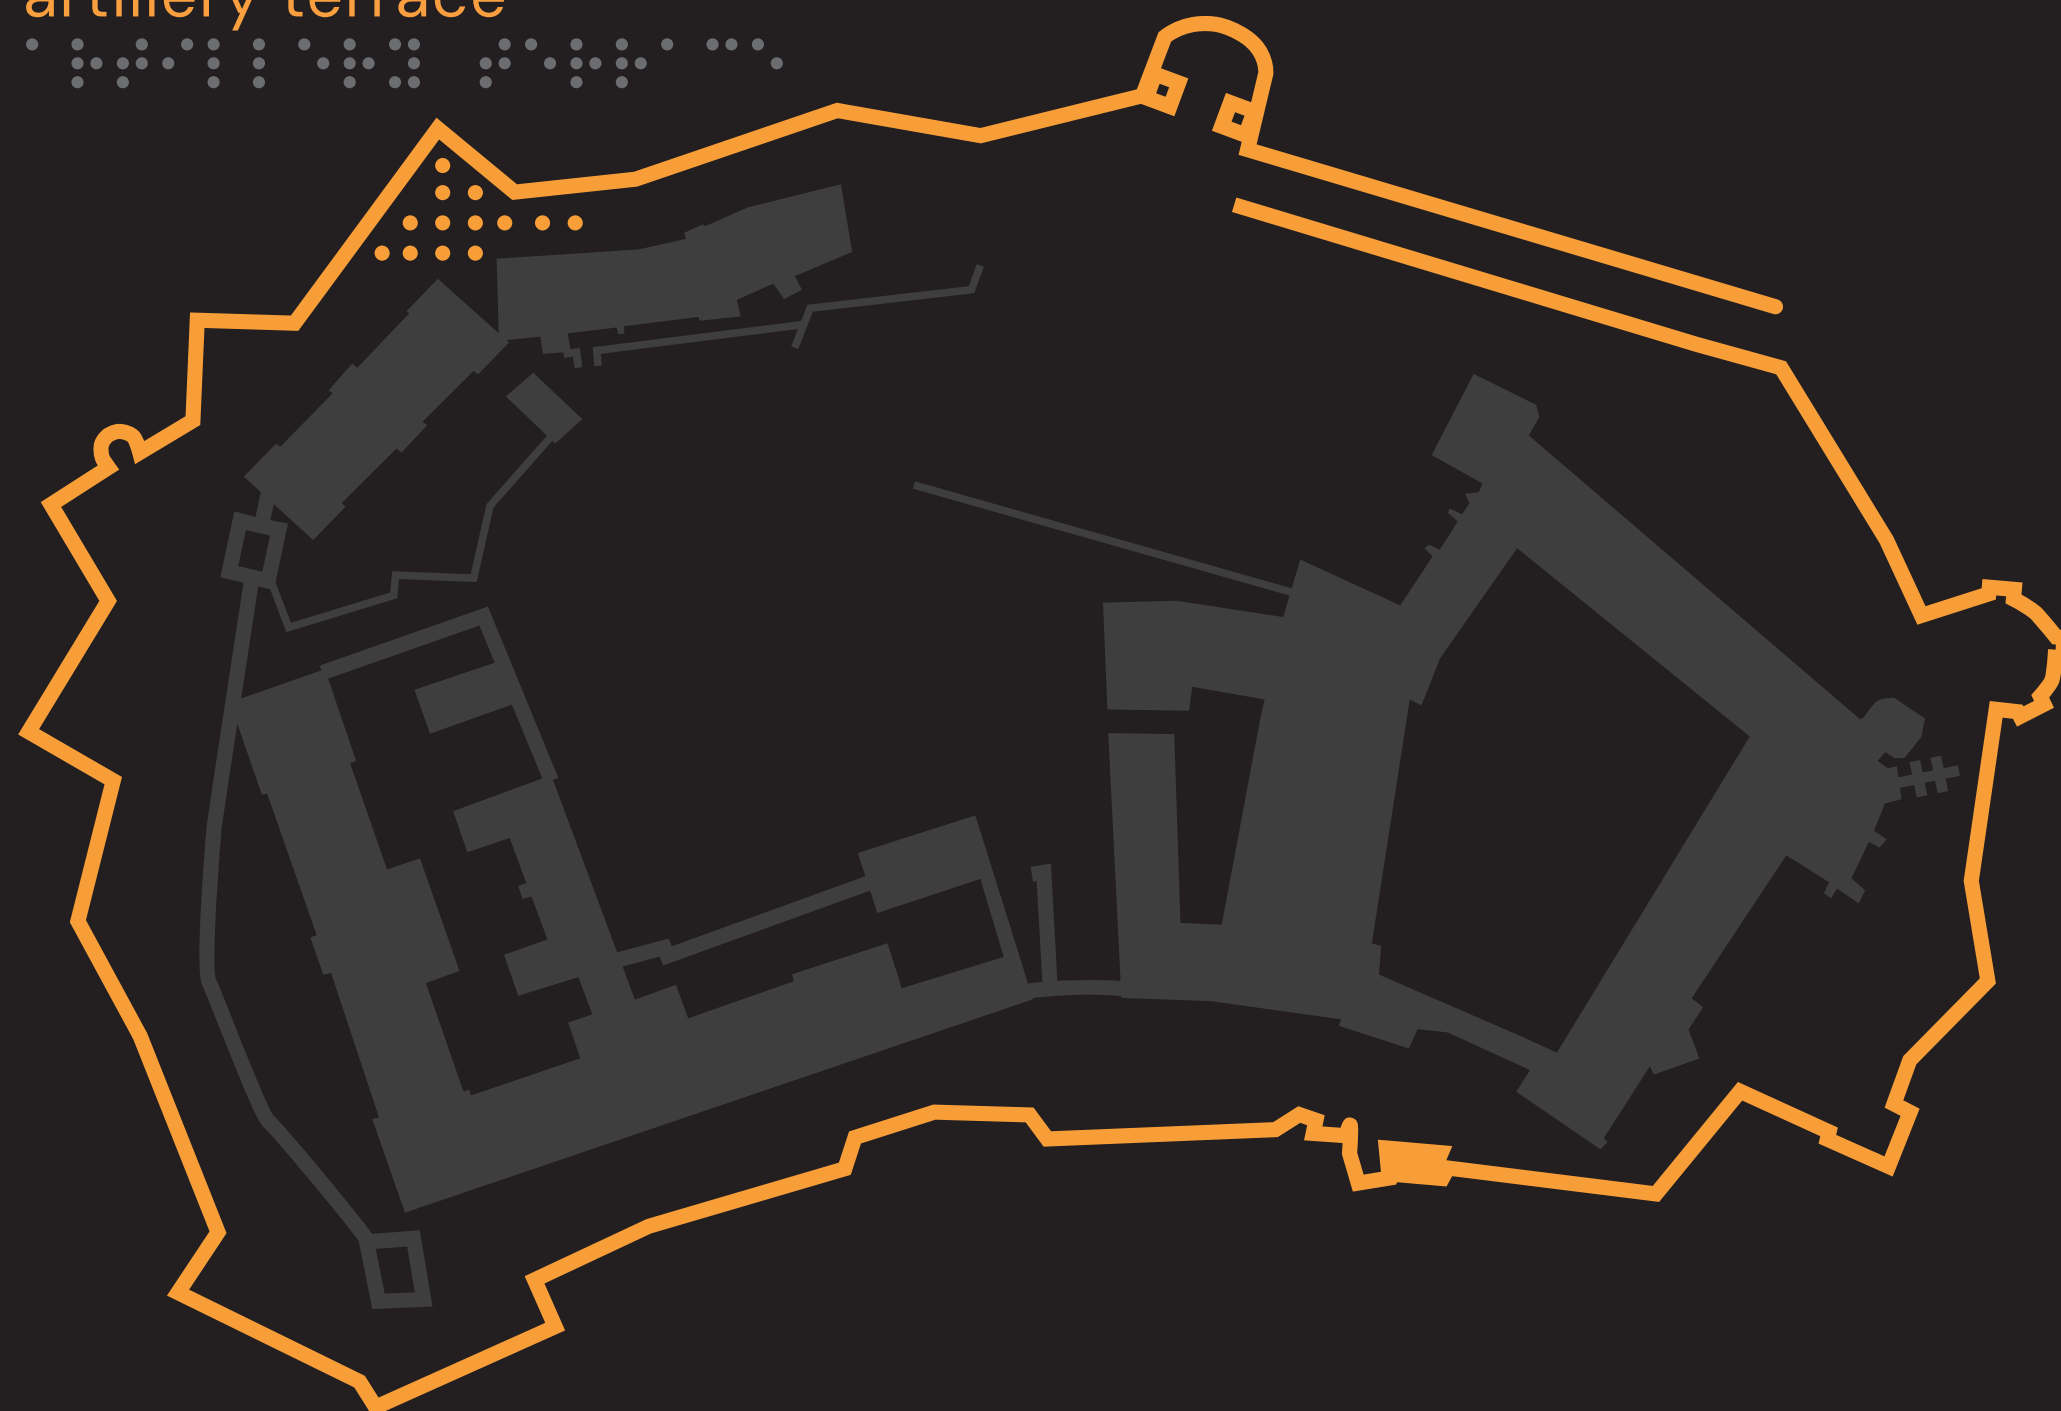
### taras artyleryjski

artillery terrace

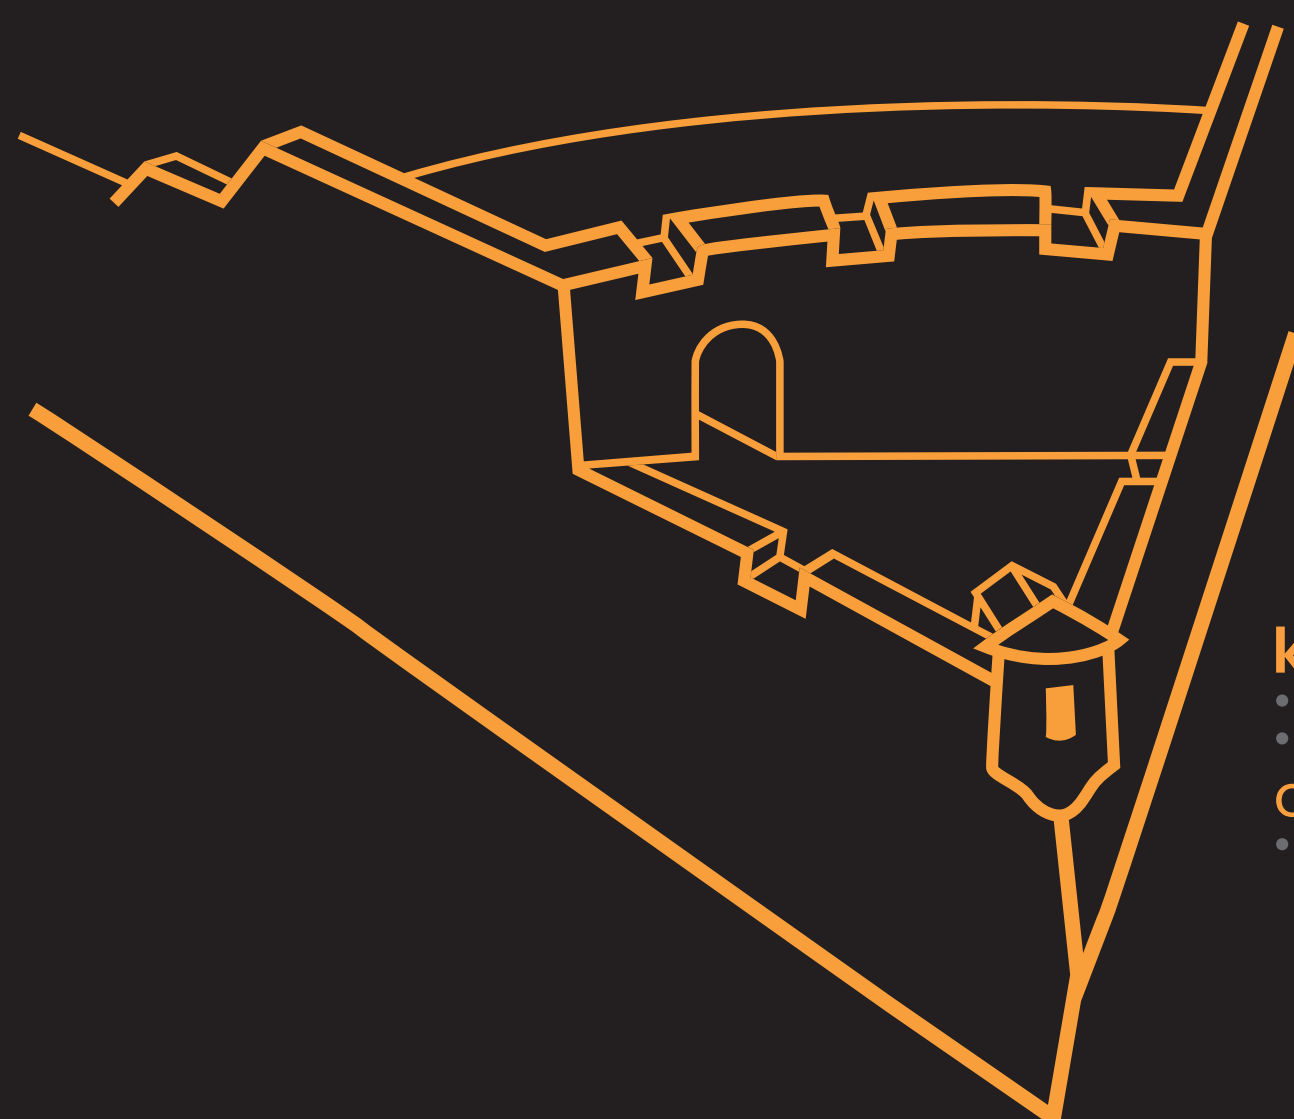
### rekonstrukcja tarasu artyleryjskiego

reconstruction of the artillery terrace
